PSERN  
EDUCATION HILL

TREE PRESERVATION PLAN

**EDUCATION HILL**  
(NEW BUILD)  
10366 172ND AVE. NE  
REDMOND, WA 98052

**SHEET NAME**  
**OVERALL  
PROPOSED  
SITE PLAN**

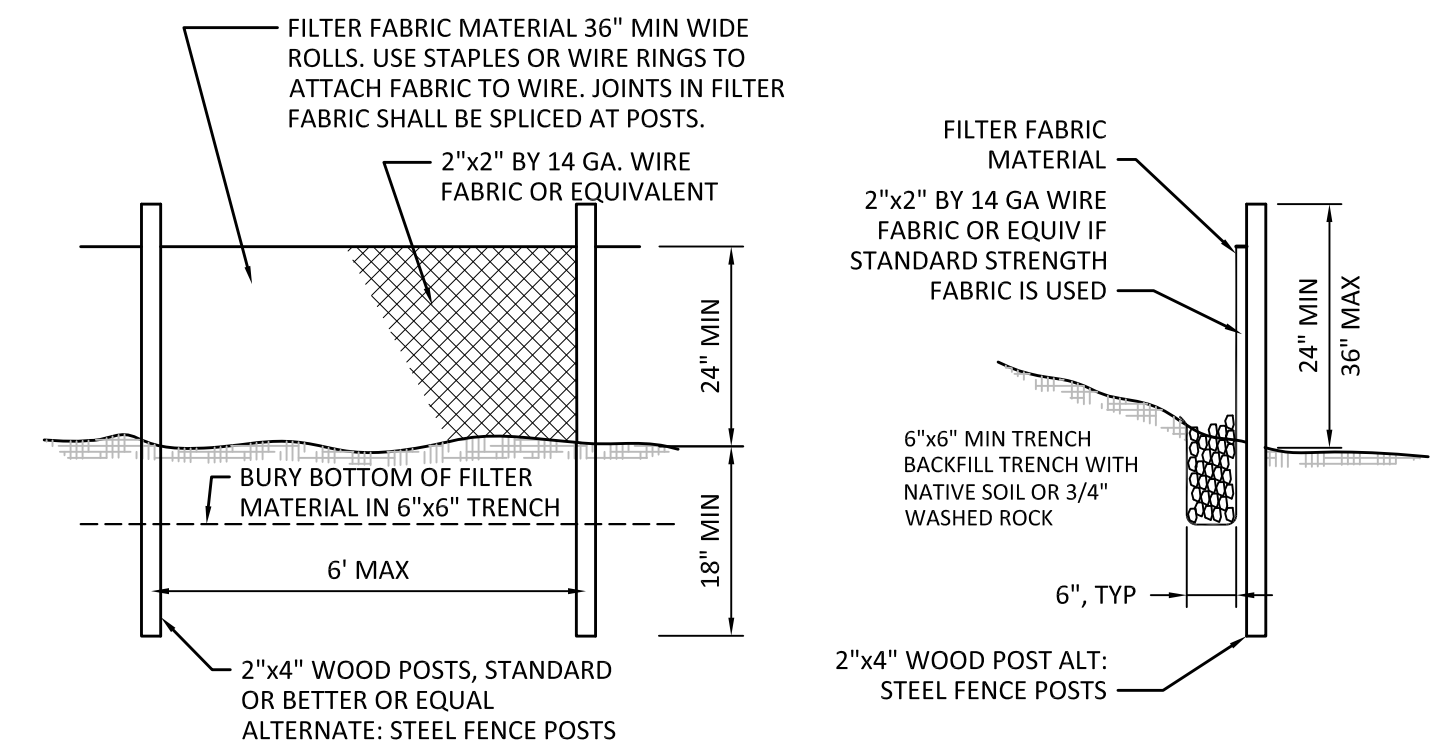
- SILT FENCE NOTES:**
1. THE FILTER FABRIC SHALL BE MIRAFI 700X OR APPROVED EQUAL, AND SHALL BE PURCHASED IN A CONTINUOUS ROLL CUT TO THE LENGTH OF THE BARRIER TO AVOID USE OF JOINTS. WHEN JOINTS ARE NECESSARY, FILTER CLOTH SHALL BE SPLICED TOGETHER ONLY AT A SUPPORT POST, WITH A MINIMUM 6 INCH OVERLAP, AND BOTH ENDS SECURELY FASTENED TO THE POST.

2. THE SILT FENCE SHALL BE INSTALLED TO FOLLOW THE CONTOURS (WHERE FEASIBLE). THE FENCE POSTS SHALL BE SPACED A MAXIMUM OF 6 FEET APART AND DRIVEN SECURELY INTO THE GROUND (MINIMUM OF 18 INCHES).

9. SILT FENCES SHALL BE INSPECTED IMMEDIATELY AFTER EACH RAINFALL AND AT LEAST DAILY DURING PROLONGED RAINFALL. ANY REQUIRED REPAIRS SHALL BE MADE IMMEDIATELY.

10. MAINTENANCE: ANY DAMAGED OR CLOGGED FENCE SHALL BE REPAIRED/REPLACED IMMEDIATELY. SEDIMENT MUST BE REMOVED WHEN THE SEDIMENT DEPTH IS 6 INCHES OR GREATER. IF CONCENTRATED FLOWS ARE EVIDENT UPHILL OF THE FENCE, THEY MUST BE INTERCEPTED AND CONVEYED TO A SEDIMENT TRAP OR POND.

**2** SILT FENCE  
SCALE: 1/2" = 1'-0"

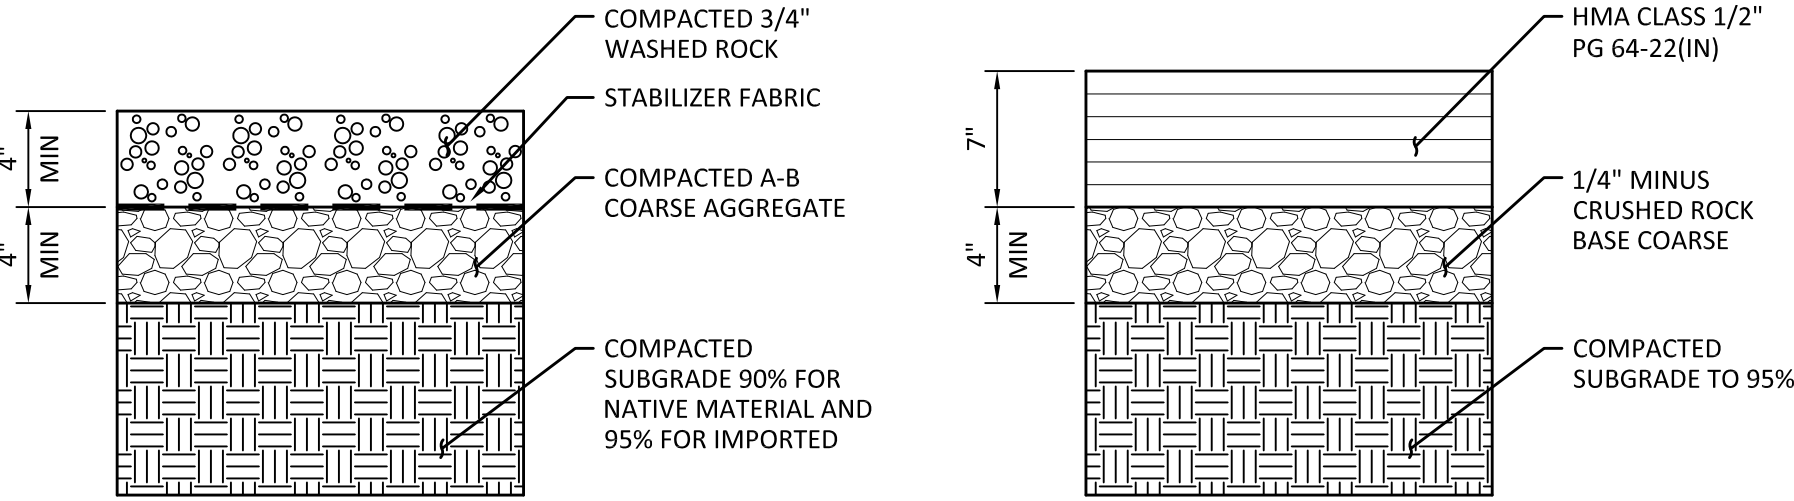
2 GRAVEL PAVING DETAIL  
SCALE: 1" = 1'-0"

3 PAVEMENT DETAIL  
SCALE: 1" = 1'-0"

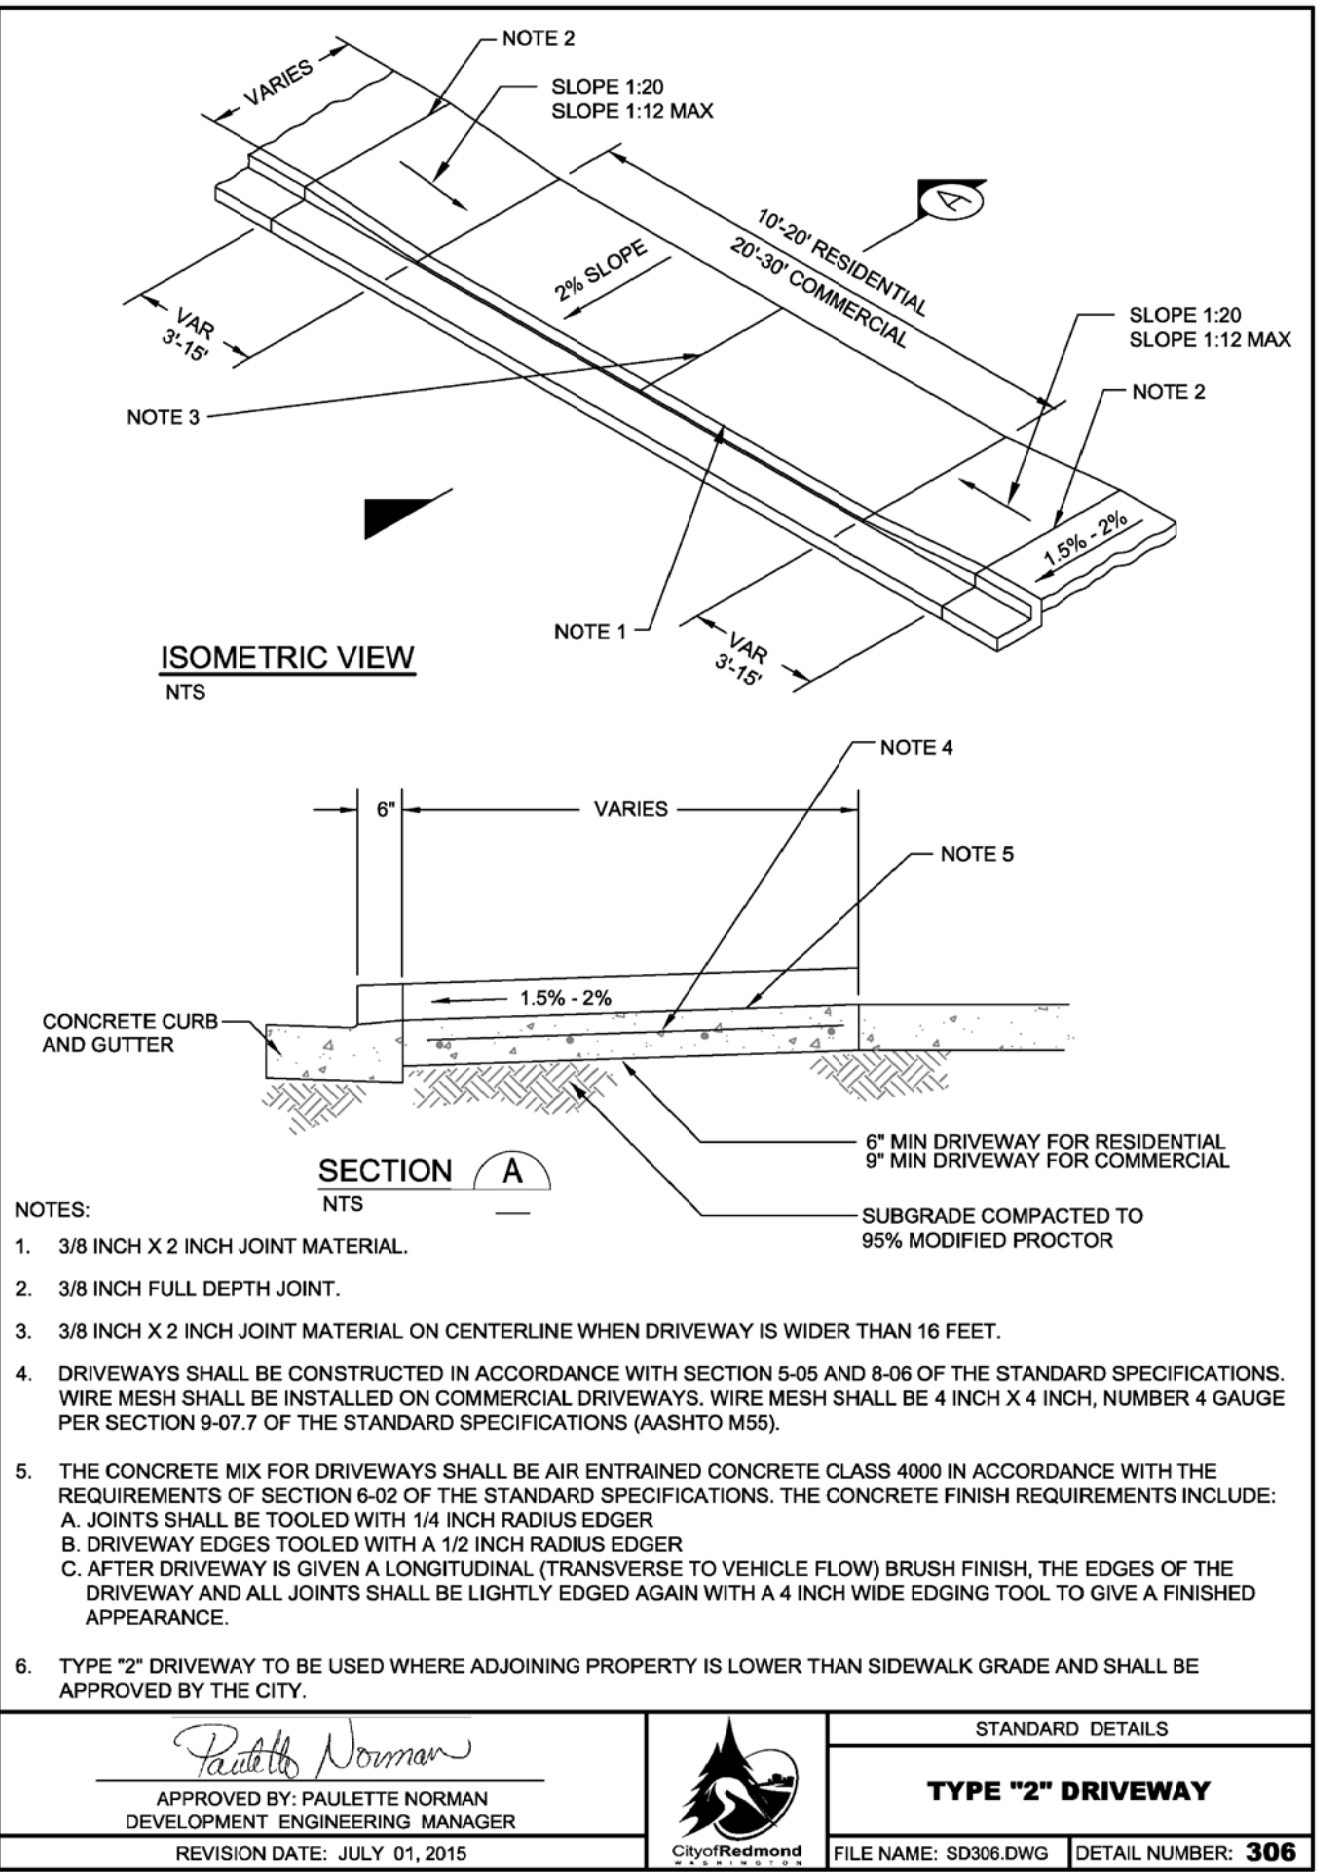
4 CITY OF REDMOND STANDARD DETAIL  
SCALE: NTS
